HERITAGE PERMIT DRAWINGS PACKAGE

HERMITAGE

HERMITAGE RESTORATION

Heritage Permit Application under Part IV of the Ontario Heritage Act to Permit the Restoration and Construction of the Hermitage located at the Main Loop Trail, Ancaster, L9G 4T7.

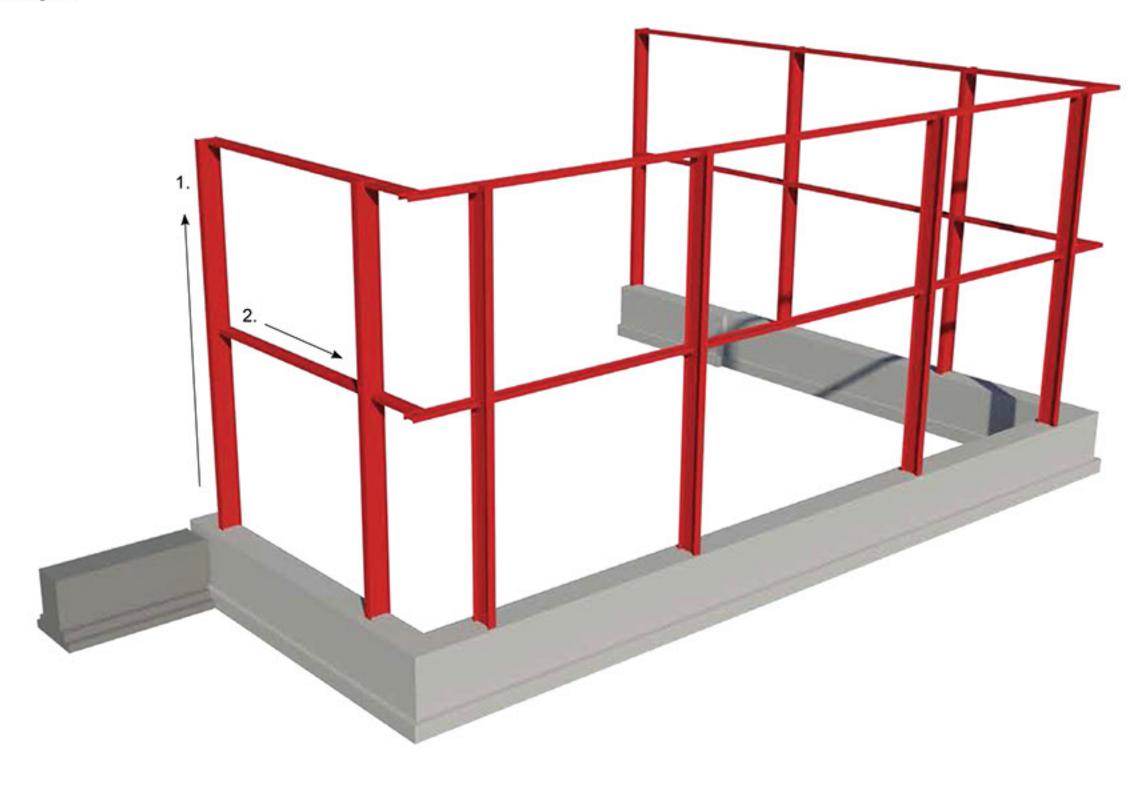
Structure

- New steel girders to be secured to new foundation (red)
 Extends to the roof capping
 New steel beams to provide more rigidity to restoration efforts
 Extends to connect girders

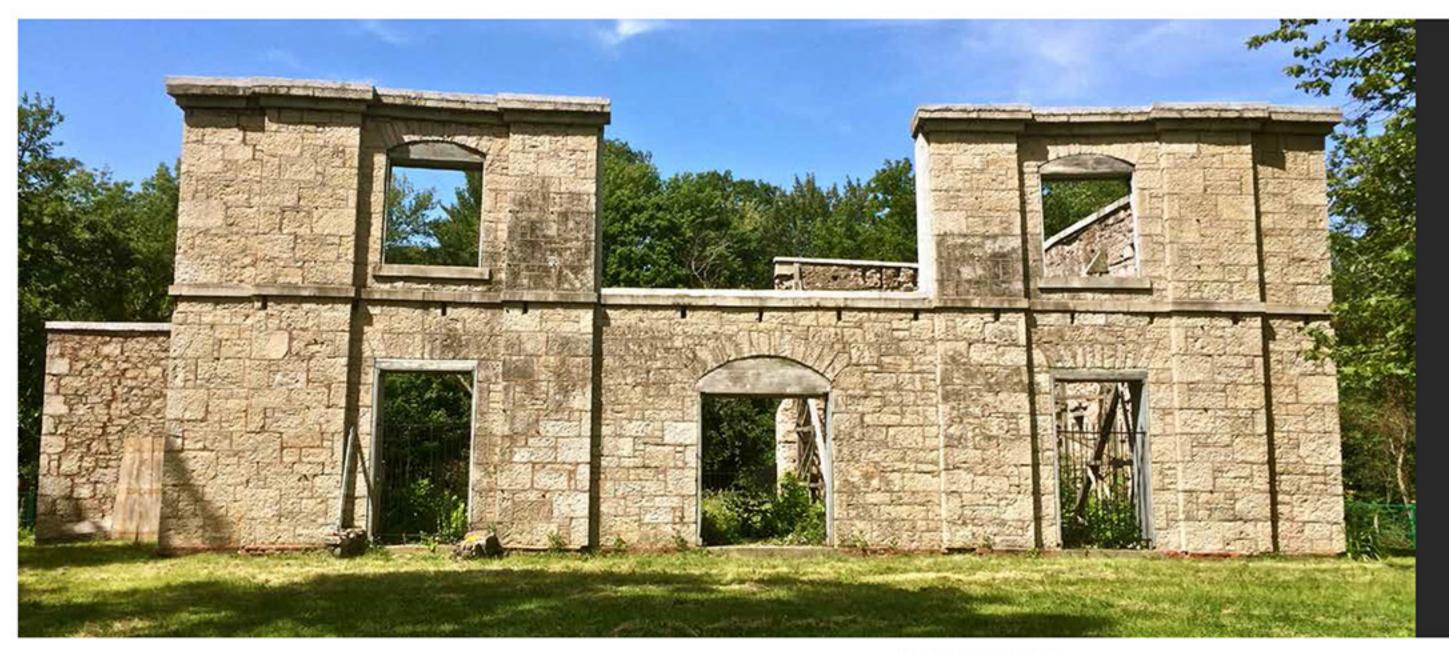
OSL ATTER Hermitage, Main Loop Trail, Ancaster, L9G 4T7
SOUTH ELEVATION - Masonry Layout
1:100

SOUTH ELEVATION Hermitage, Main Loop Trail, Ancaster, L9G 4T7

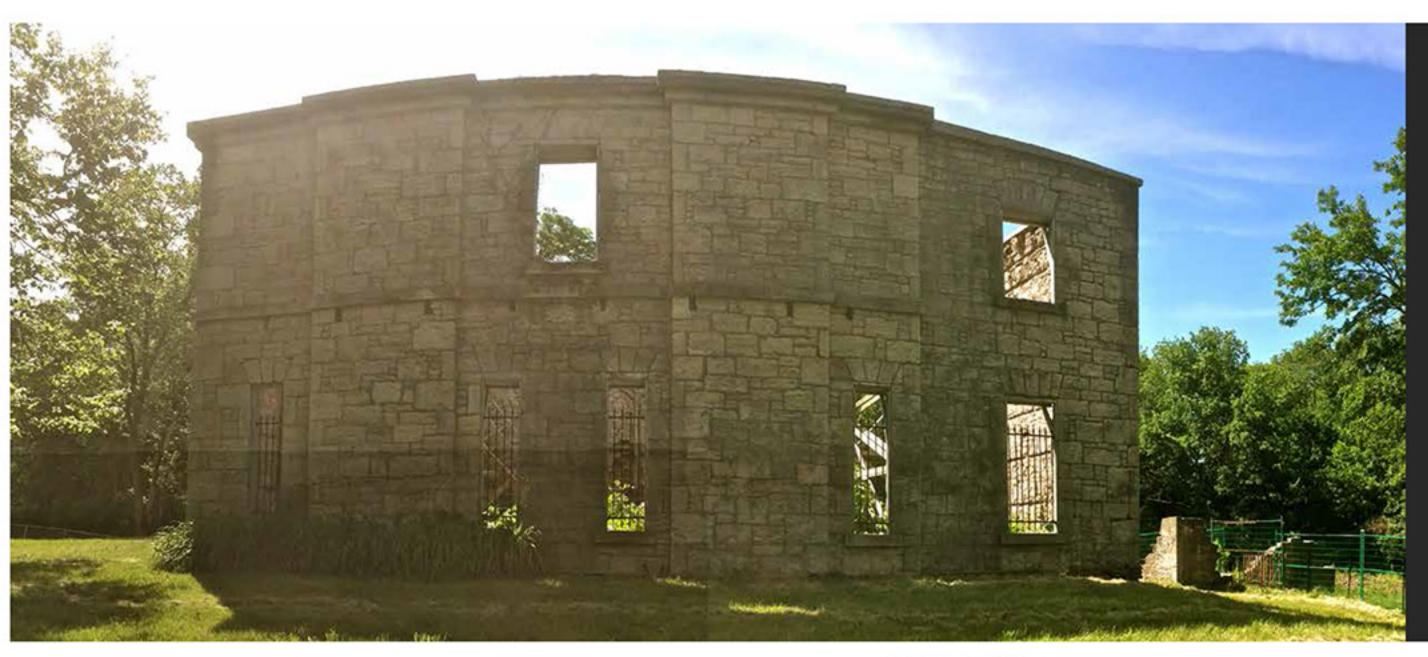
A9 Hermitage, Main Loop Trail, Ancaster, L9G 4T7
EAST ELEVATION - Masonry Layout
1:100

EAST ELEVATION Hermitage, Main Loop Trail, Ancaster, L9G 4T7

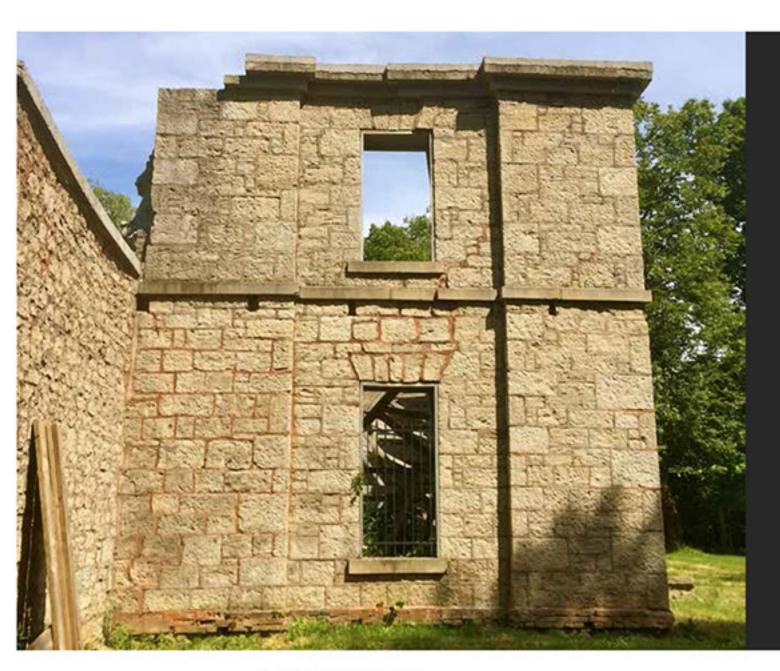
WEST ELEVATION Hermitage, Main Loop Trail, Ancaster, L9G 4T7
